EAGLE EYE®
NEW HOME INSPECTIONS

PRE-COMPLETION INSPECTION REPORT

1 Example Road, Example
Town, Hertfordshire,
SW1A 1AA

23rd April 2025

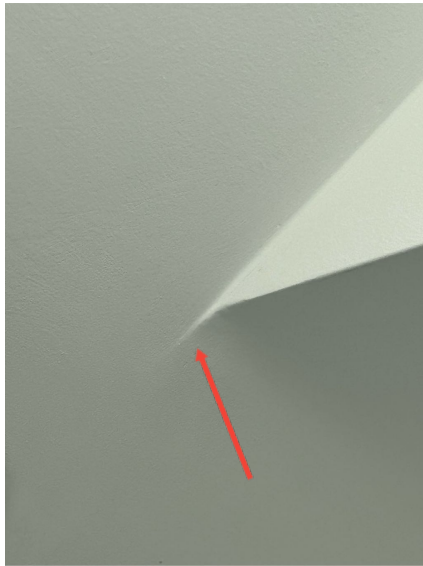
Defect number: 1

The dormer window aperture finish is inconsistent. The finish between the wall and the ceiling is to be improved.

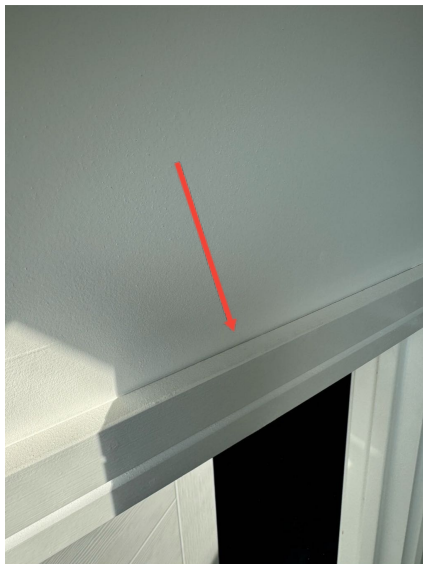
Defect number: 2

The top of the doorway between Bedroom 1 and En Suite 1 is missing caulk. There is currently a gap between the architrave and plasterboard.

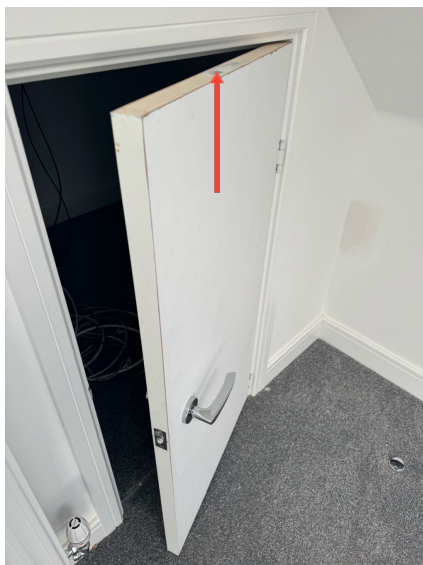
Defect number: 3

The top of the eaves cupboard door within Bedroom 1 needs to be painted.

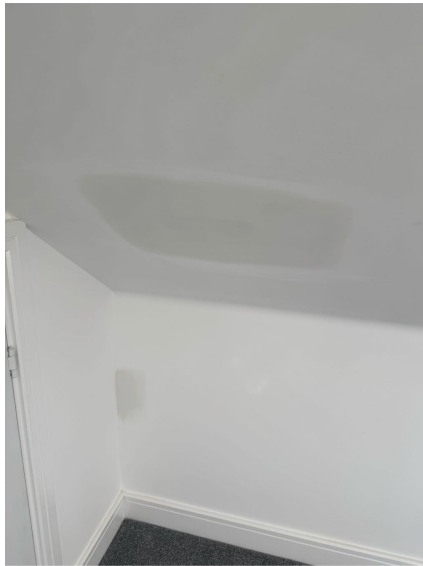
Defect number:4

Making good patches to be sanded and decorated.

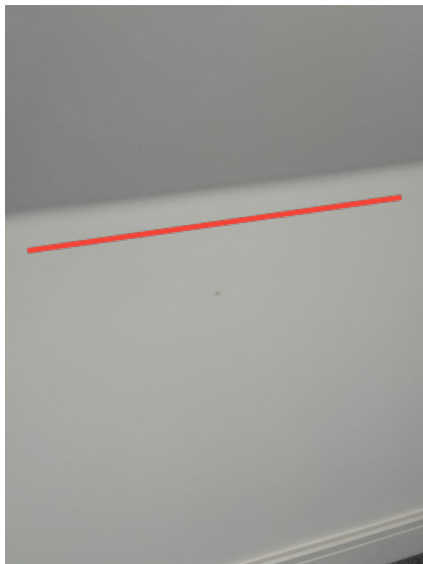
Defect number:5

The sloped ceiling plasterboard joint is not straight throughout the bedroom. A laser or string should be used to achieve a straight level finish.

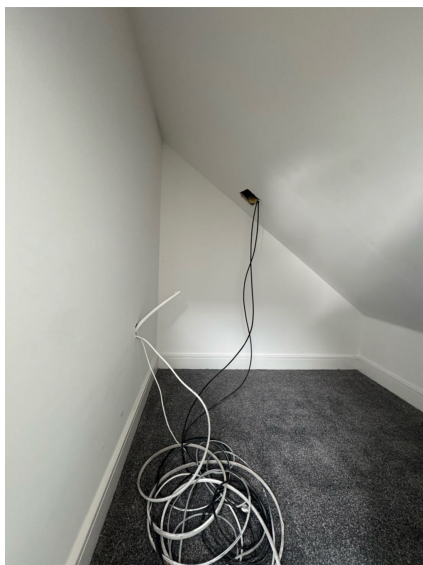
Defect number:6

The PV panel control board requires installing and commissioning.

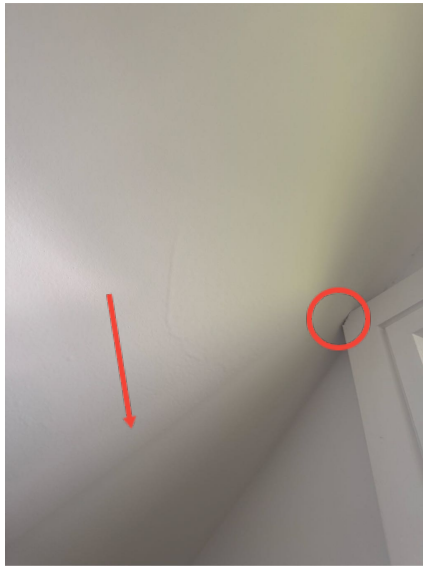
Defect number: 7

The decoration finish requires improving inside the eaves cupboard within Bedroom 1. Caulk is required between the architrave and sloped ceiling.

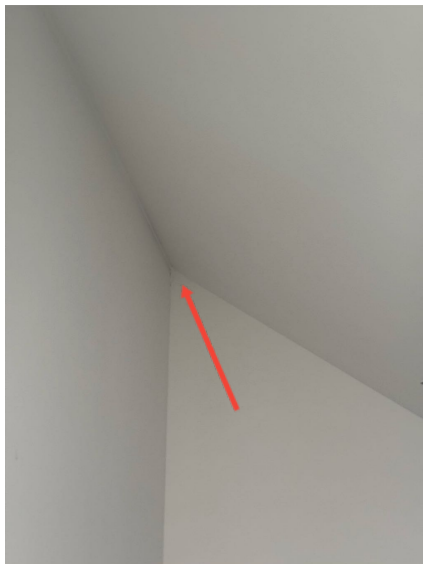
Defect number: 8

The decoration finish requires improving inside the eaves cupboard within Bedroom 1.

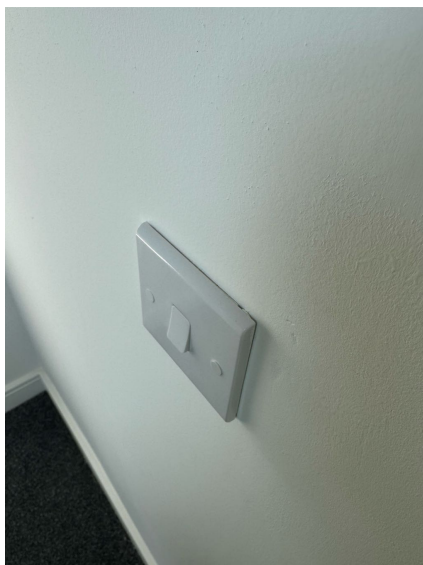
Defect number: 9

The light switch plate is not flush with the wall. It requires screwing flush or the box within the wall should be set deeper.

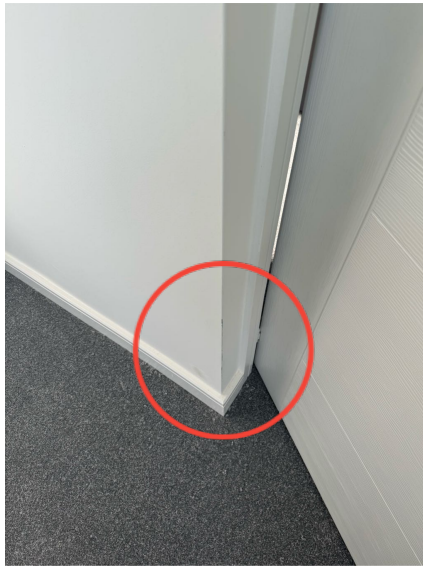
Defect number: 10

The decoration finish needs to be improved at the corner of the wall behind the door opening to the en suite.

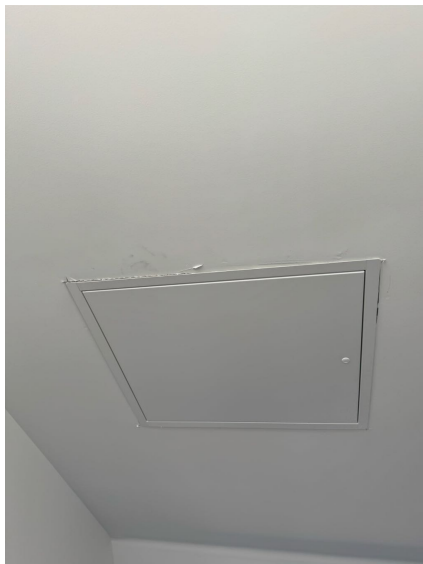
Defect number: 11

The decoration finish around all sides of the loft hatch requires improving.

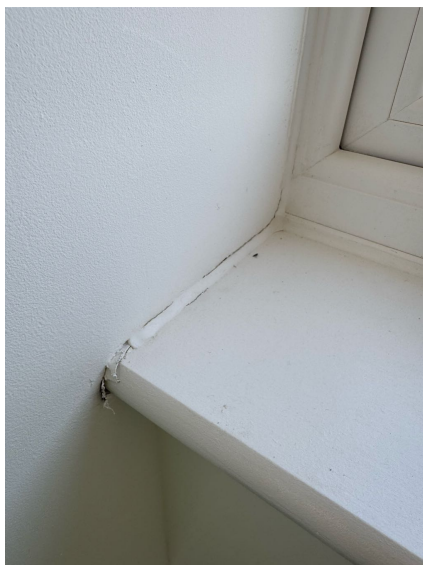
Defect number: 12

The mastic finish to the dormer window board is poor and requires cutting out and re-sealing.

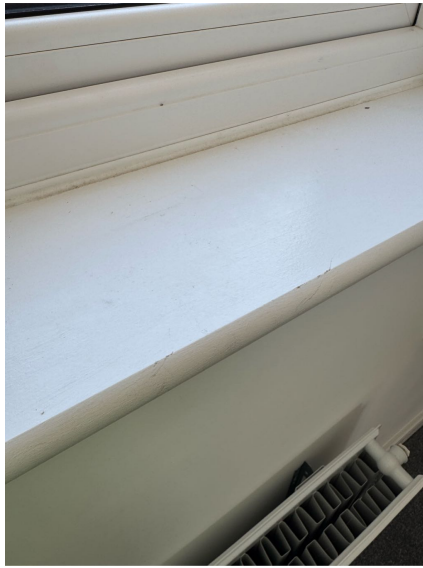
Defect number: 13

The dormer window board requires re-decorating.

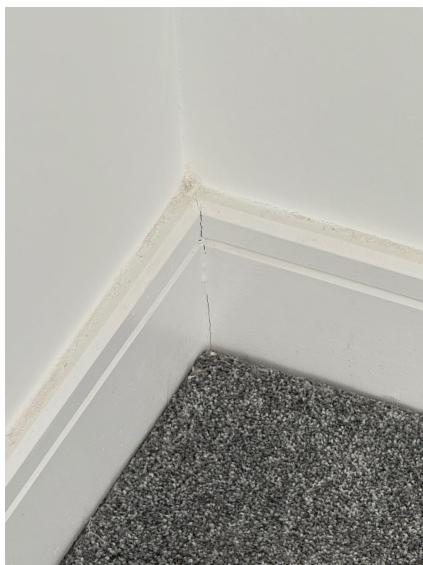
Defect number: 15

There are various settlement cracks between joinery, and between plasterboard and joinery throughout the bedroom. These require caulk and are to be subsequently painted.

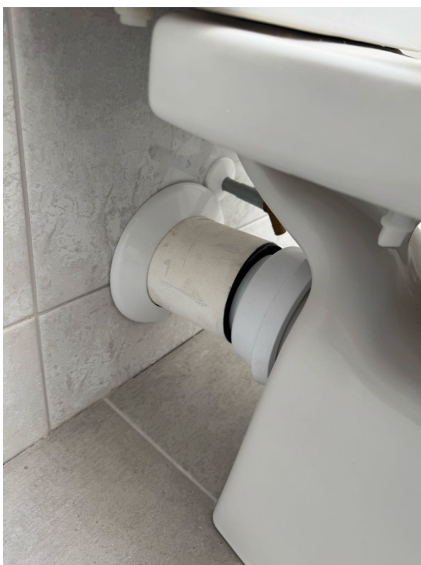
Defect number: 18

The toilet waste pipe collar requires cleaning.

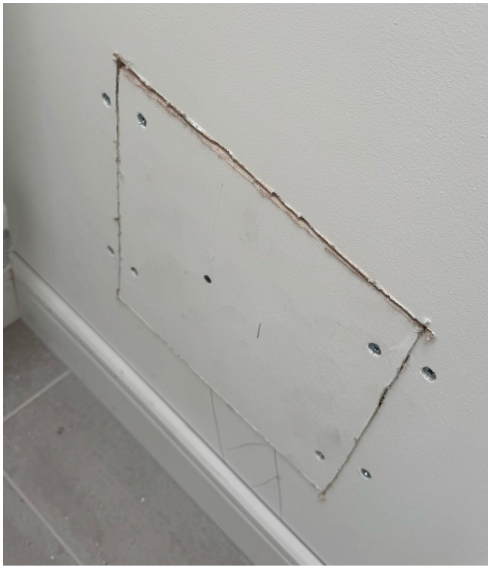
Defect number: 19

A plasterboard cut out has been patched and now requires making good before decoration.

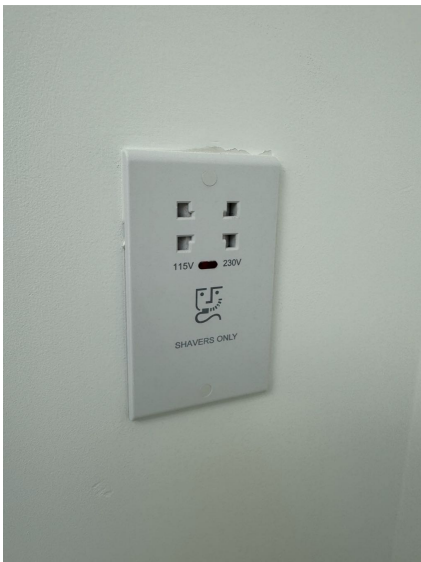
Defect number: 20

The decoration finish needs to be improved around the shaver socket.

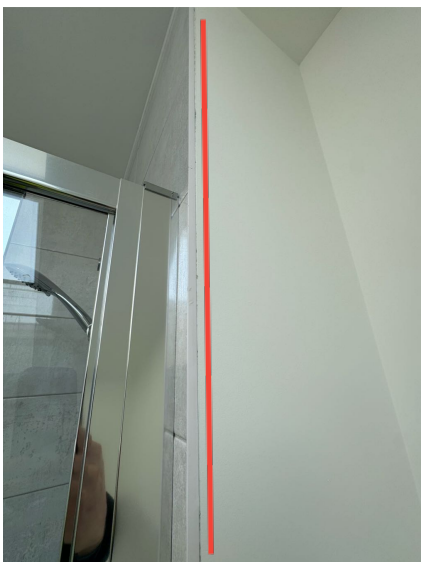
Defect number: 21

The decoration finish adjacent to the wall tiling trim needs to be improved.

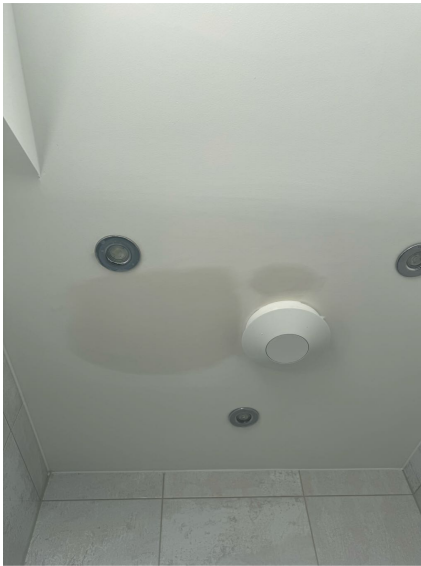
Defect number: 22

The ceiling patches require sanding and decorating.

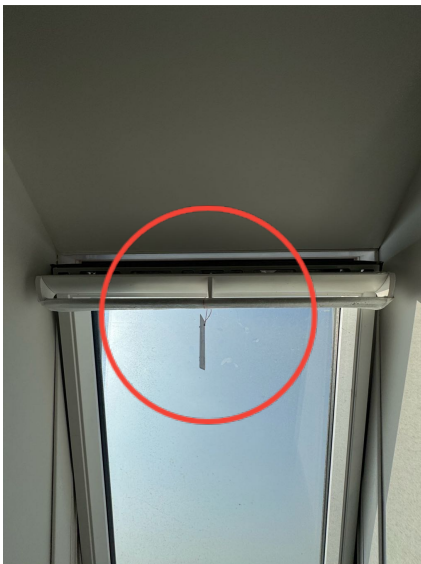
Defect number: 23

The warranty tag needs to be removed from the roof window. The tag should be kept in a safe and secure place in case of the need for future use.

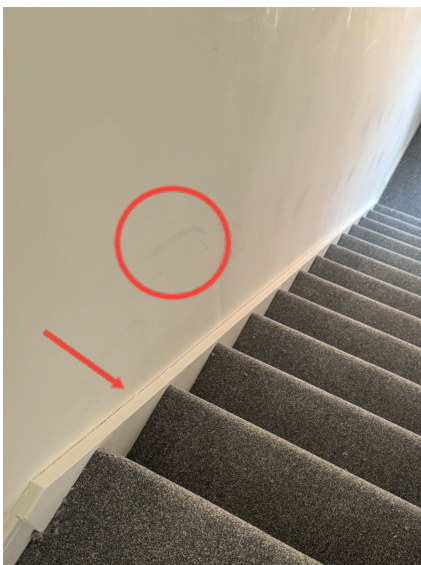
Defect number: 24

The stair string requires caulk due to settlement, and there are various scuff marks on the stair wall that require decorating. It is suggested that the stair wall is re-rolled to achieve a consistent finish.

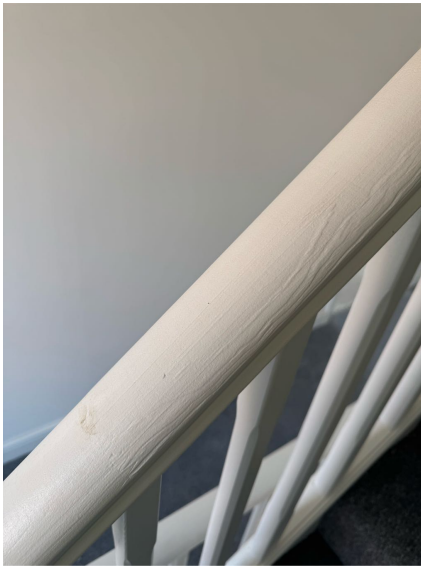
Defect number: 25

The handrail requires sanding and re-decorating. The handrail is currently rough to the touch and the decoration finish is poor.

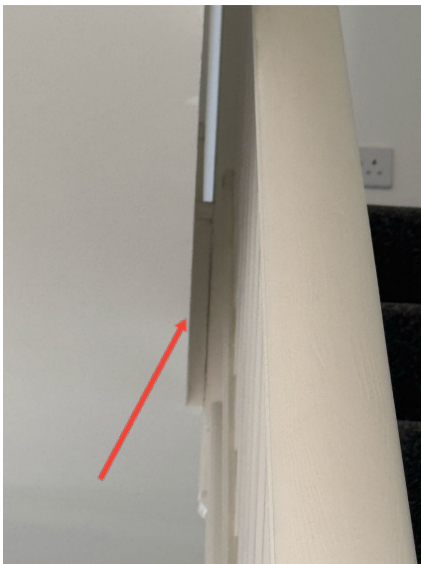
Defect number: 26

The gap and finish between the staircase and wall requires improving.

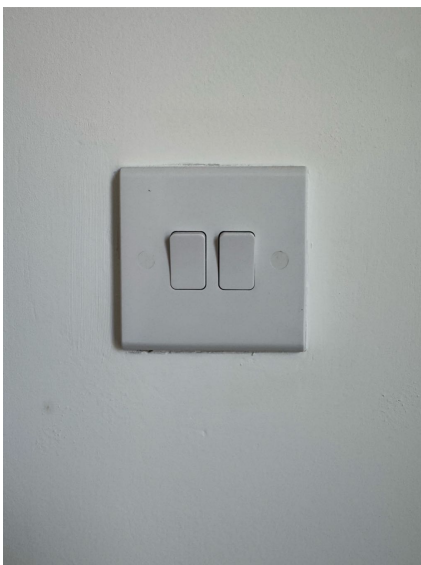
Defect number: 27

The decoration finish around the two gang light switch requires improving.

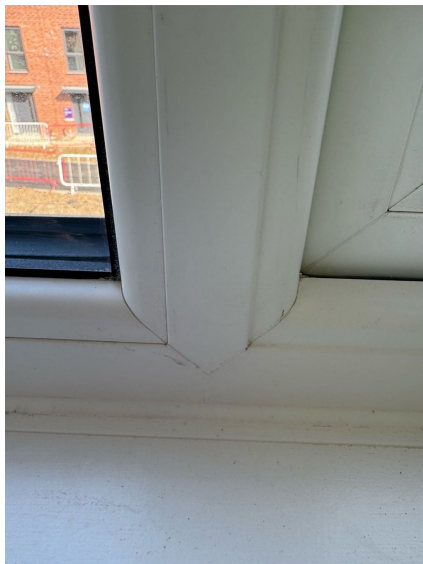
Defect number: 29

There are various marks to the landing window frame. These need to be repaired if they cannot be cleaned off.

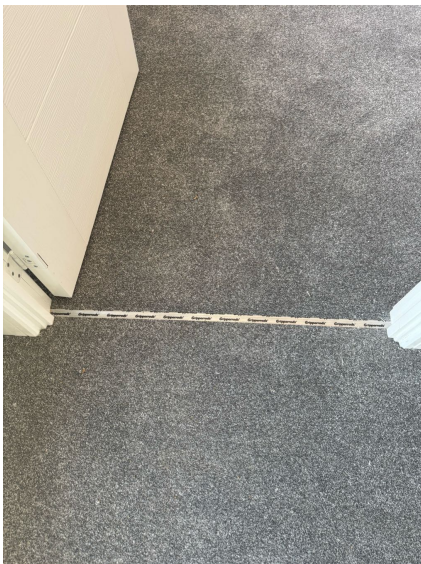
Defect number: 32

The carpet door bar protective tape requires removing.

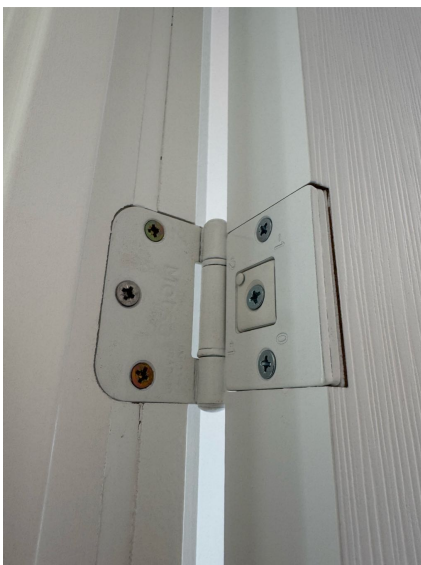
Defect number: 33

Different coloured screws have been used to fix this door hinge plate. A consistent screw type should be used.

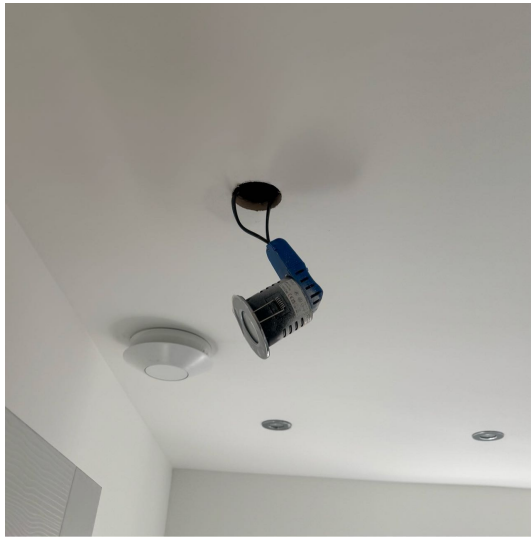
Defect number: 34

This downlight is not fitted within the ceiling.

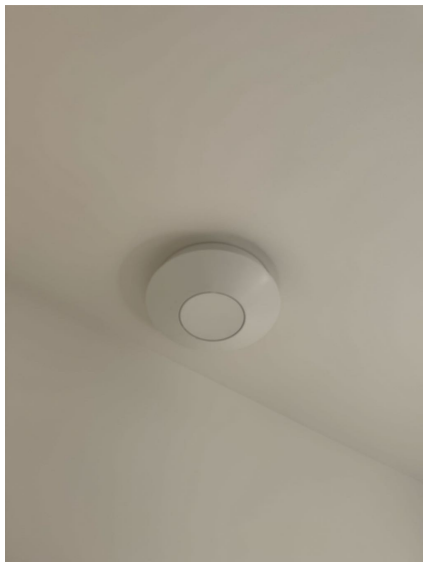
Defect number: 35

The bathroom extractor fan does not work despite the wall plate switch being turned on, the isolator switch being turned on, and the relevant zonal isolator switch on the consumer unit being turned up. This is likely a wiring fault.

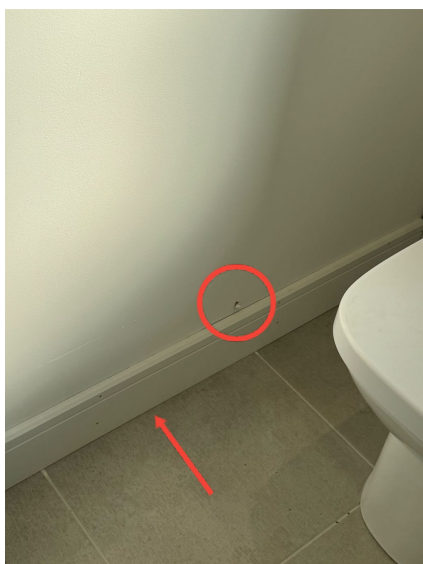
Defect number: 36

Paint filler and decoration is required to the damaged wall. Mastic is also required between the floor tiling and the skirting board.

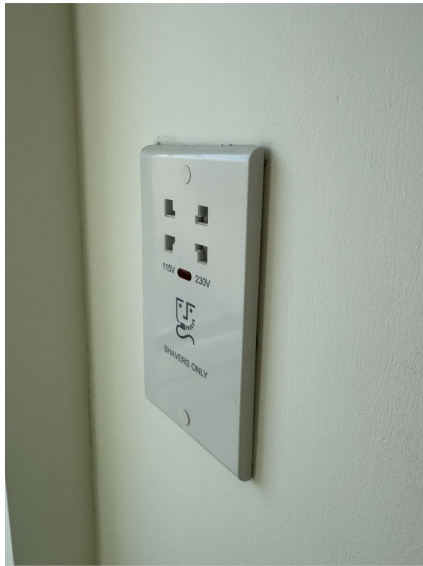
Defect number: 37

The decoration finish needs to be improved around the shaver socket.

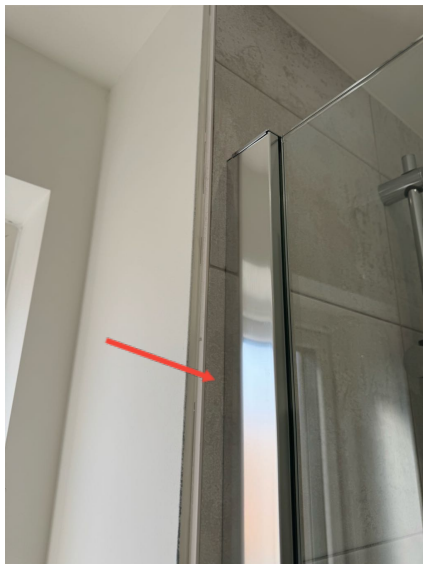
Defect number: 38

Clear sanitary mastic is required to the bathroom bath screen.

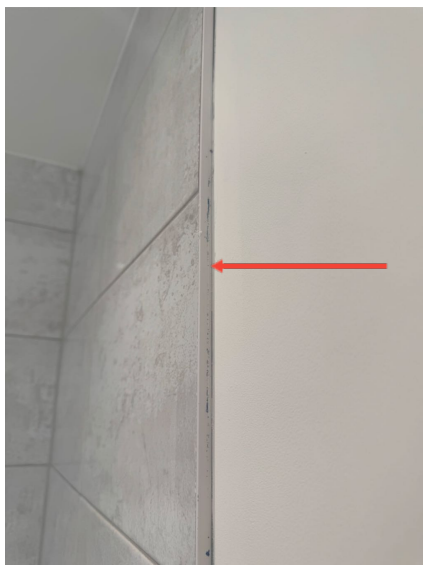
Defect number: 39

The decorator's protective tape residue requires cleaning off from the wall tile trim.

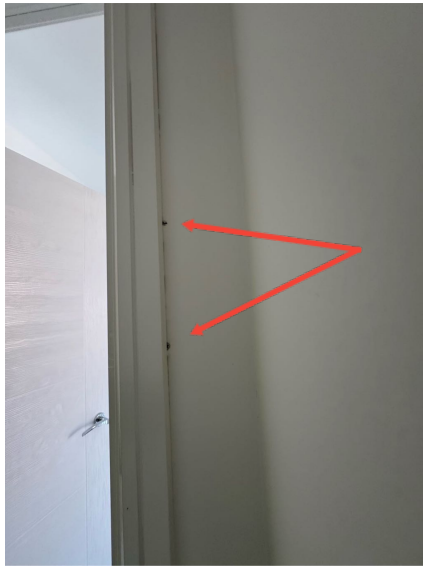
Defect number: 40

Paint filler is required over plasterboard screw heads prior to decoration.

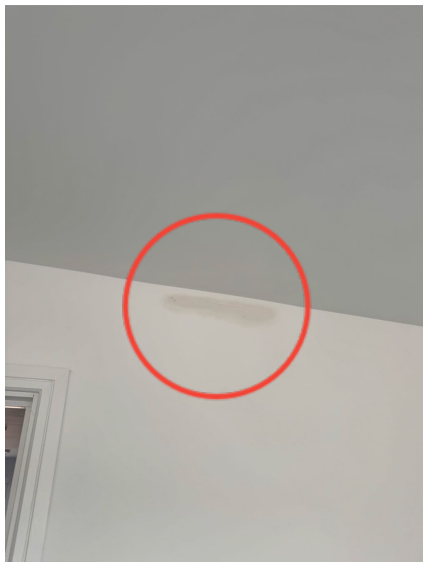
Defect number: 41

Decorate the patch beside the doorway. It has already been sanded.

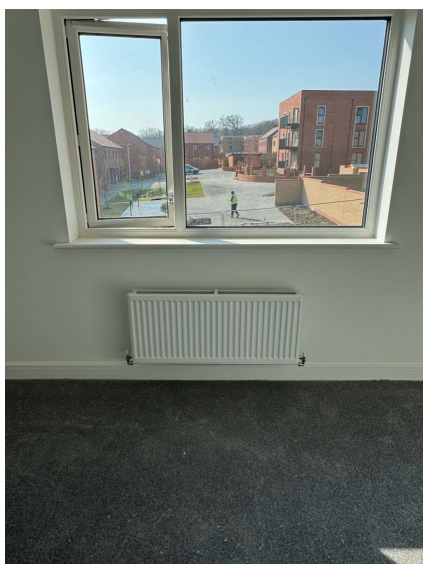
Defect number: 42

The bedroom radiator is not centralised to the window.

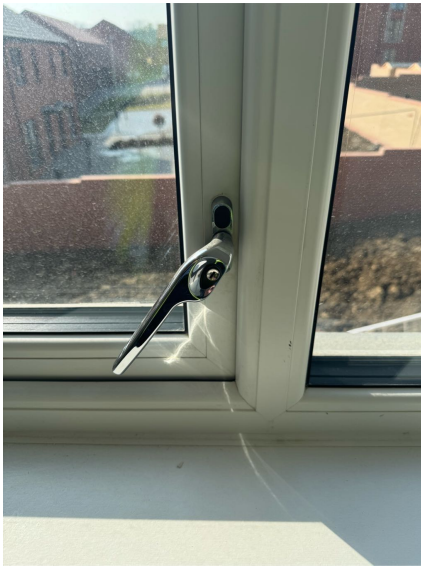
Defect number: 43

The window handle is tight to open and close. It requires lubricant (WD-40 is suggested) to ease its use of operation.

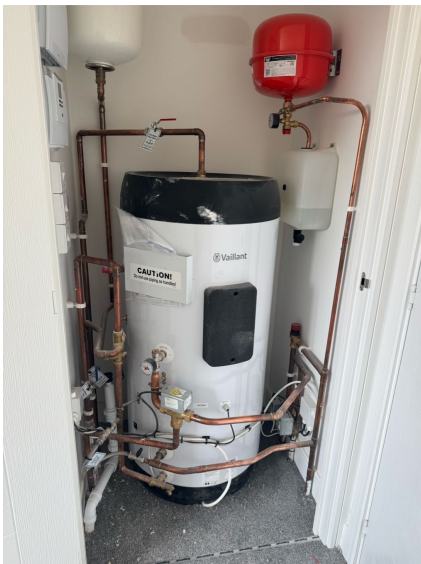
Defect number: 44

Lagging is required to the cylinder tank's hot water pipes. This is a safety concern if not carried out.

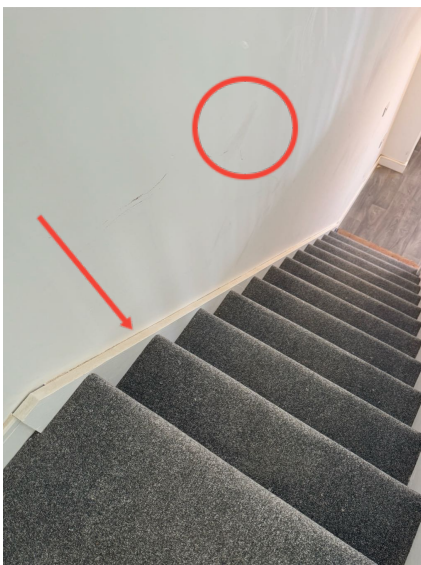
Defect number: 45

The stair string requires caulk due to settlement, and there are various scuff marks on the stair wall that require decorating. It is suggested that the stair wall is re-rolled to achieve a consistent finish.

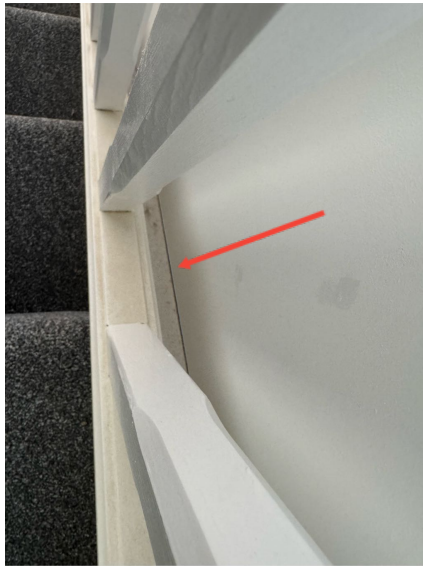
Defect number: 46

Caulk gap between staircase and wall.

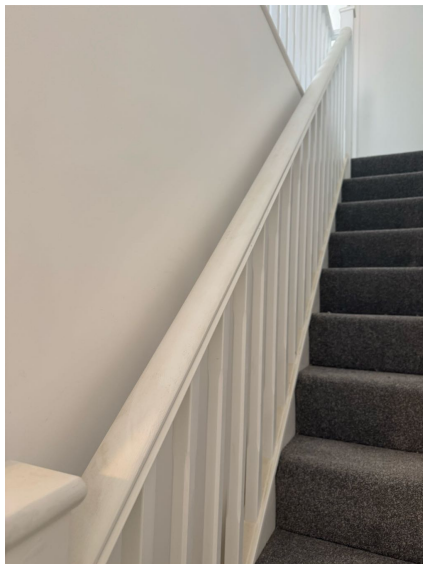
Defect number: 47

The handrail requires sanding and re-decorating. The handrail is currently rough to the touch and the decoration finish is poor.

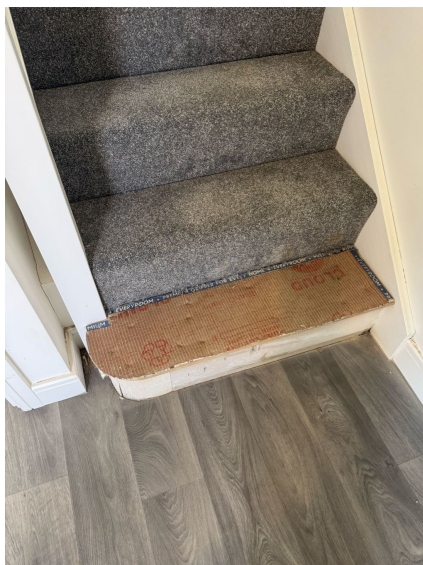
Defect number: 48

The bottom step requires carpet.

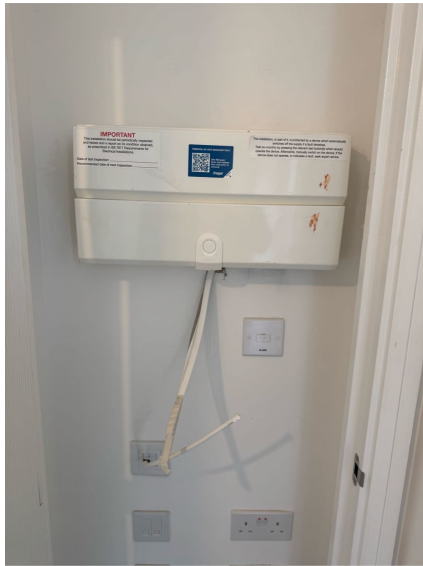
Defect number: 49

The PV panel cable needs to be wired into the consumer unit and subsequently commissioned.

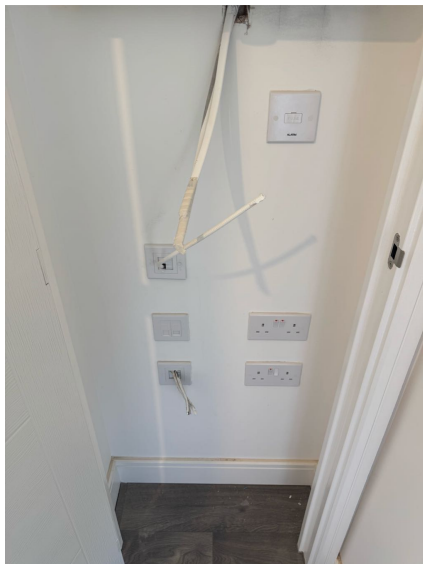
Defect number: 50

Broadband connectivity is required to the house.

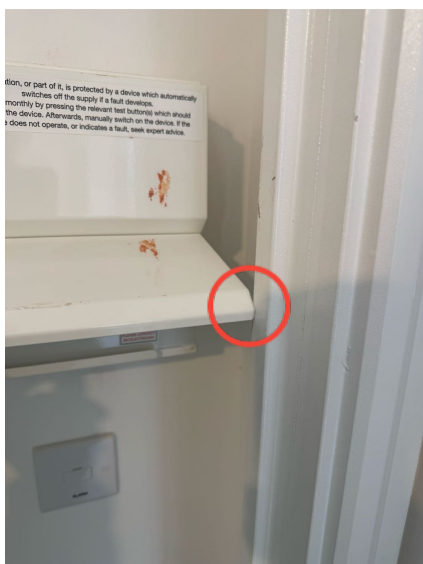
Defect number: 51

The consumer unit door clashes with the door frame's stopper. The consumer unit position needs to be adjusted to allow the consumer unit door to open and close freely.

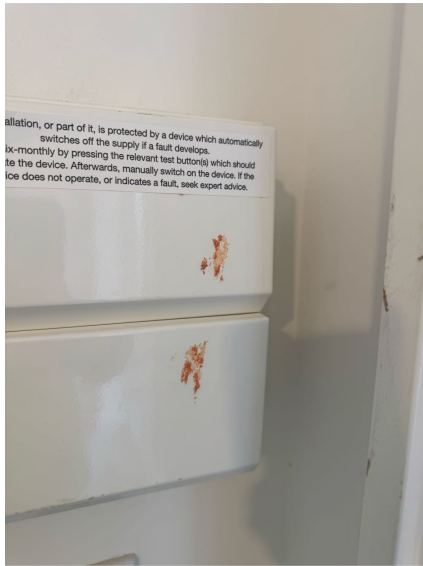
Defect number: 52

The consumer unit needs to be cleaned. Expanding foam is currently on the consumer unit.

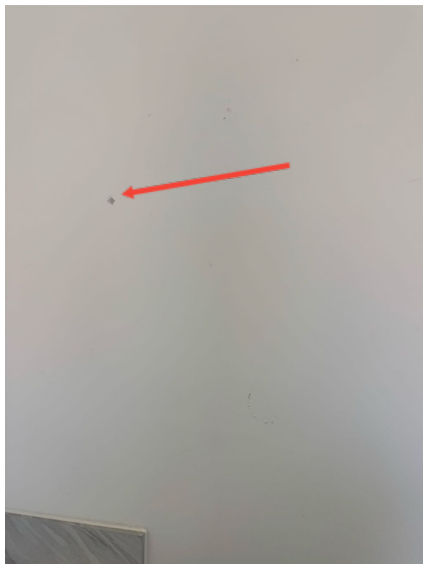
Defect number: 53

Fill and decorate the damaged wall.

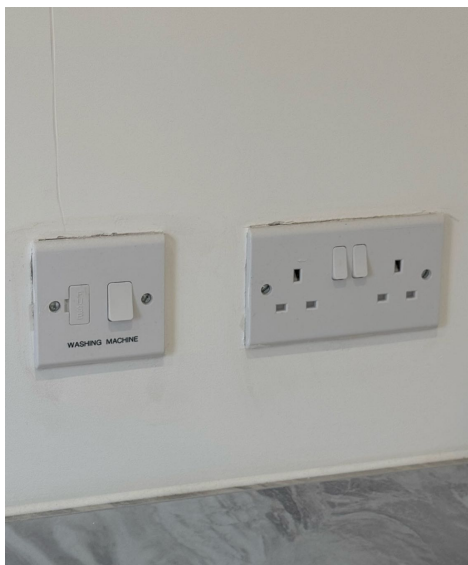
Defect number: 54

The decoration finish needs to be improved around the washing machine switch plate and the double socket plate.

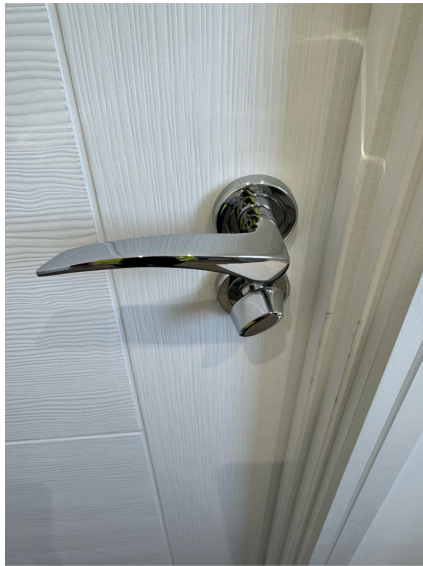
Defect number: 55

The cloakroom thumb turn lock is currently not operational. The door needs to be adjusted to ensure its operation.

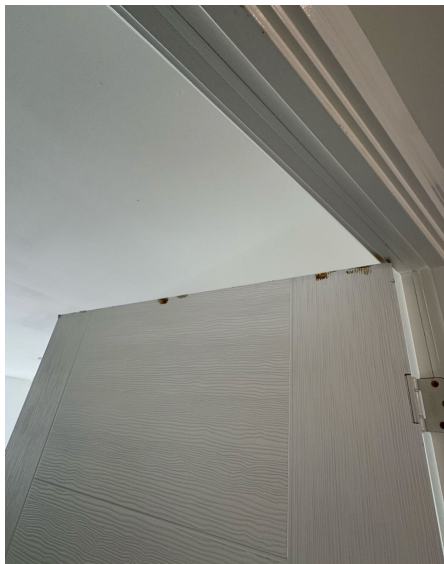
Defect number: 56

The top of the kitchen door is severely damaged. It is a fire door and should be changed to ensure its fire resistance integrity. The fire door should have a minimum fire resistance of 30 minutes. It is a FD30 rated door.

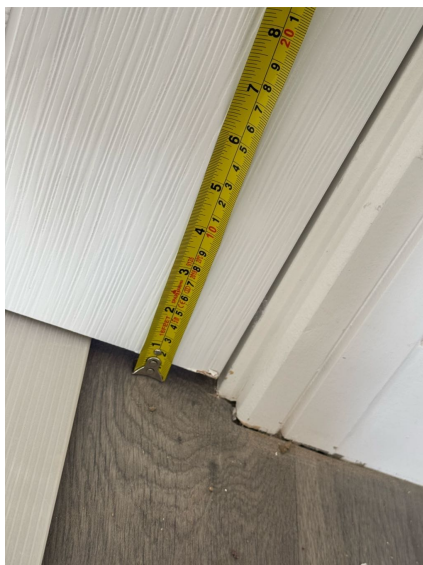
Defect number: 57

The gap beneath the kitchen fire door to the finished floor vinyl covering is excessive and non-compliant. The door has either been excessively cut down or the frame height needs to be reduced to ensure compliance. The gap cannot exceed 10mm as per the NHBC standard 9.1.4 Doors and windows.

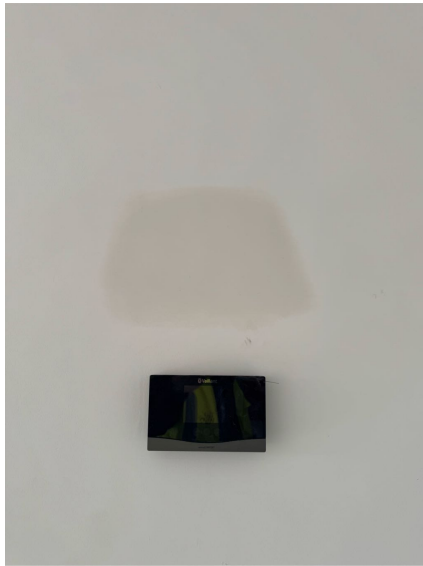
Defect number: 58

Decorate the patch above the thermostat. The patch has already been sanded.

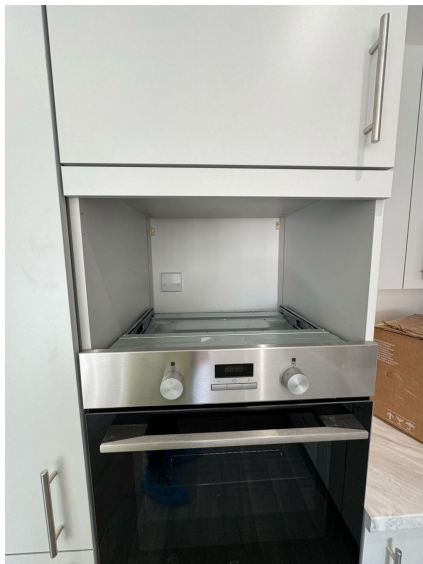
Defect number: 59

The supplied oven housing is incorrect for the single oven that has been chosen by the customer. The correct housing needs to be supplied and installed. Provision needs to be made for the oven to be reinstalled after the housing is corrected.

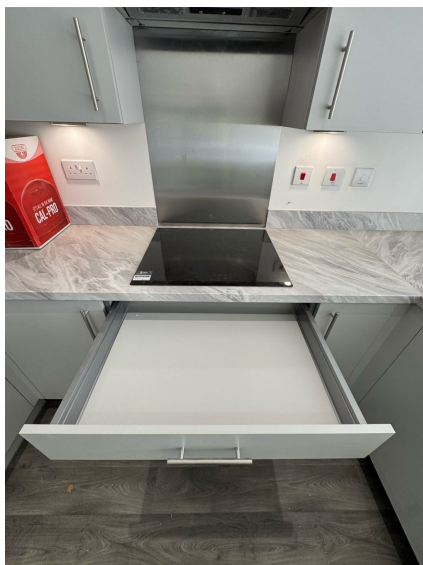
Defect number: 60

The kitchen is missing the cutlery tray and it needs to be supplied and installed.

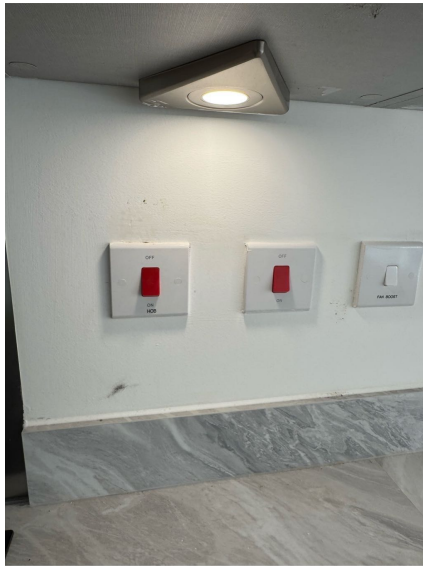
Defect number: 61

The decoration finish needs to be improved around the kitchen appliance isolator switch plates.

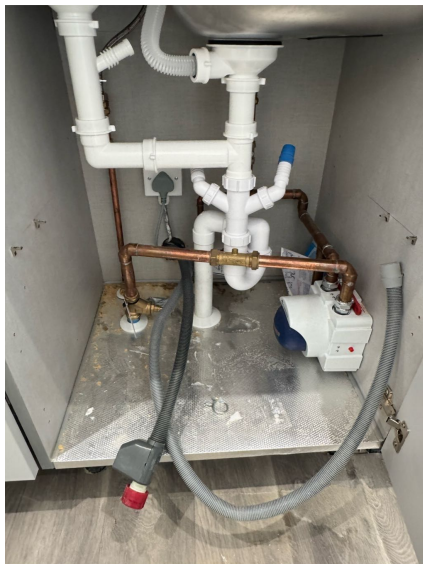
Defect number: 62

The dishwasher water feed and discharge hose have not been connected beneath the kitchen sink. The unit has also been left in a poor state and needs to be cleaned.

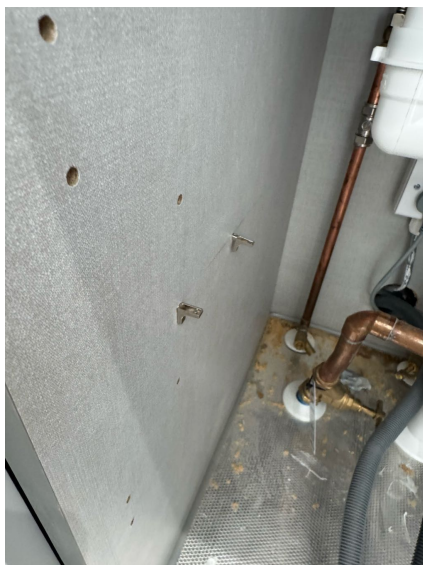
Defect number: 63

Shelf brackets have been installed to the unit beneath the kitchen sink but the shelf is missing. This needs to be supplied and installed.

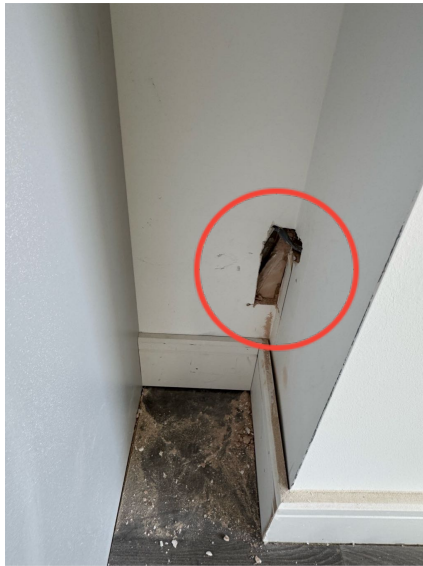
Defect number: 64

A large hole was found beneath the kitchen worktop adjacent to the soil ventilation pipe boxing. This needs to be made good and then decorated. The mess also needs to be cleaned up.

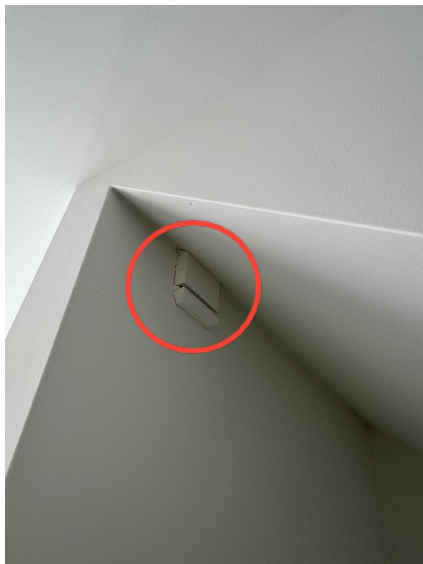
Defect number: 65

The finish around the exposed newel post needs to be improved. This is beneath the stairs in the adjoining open plan lounge space.

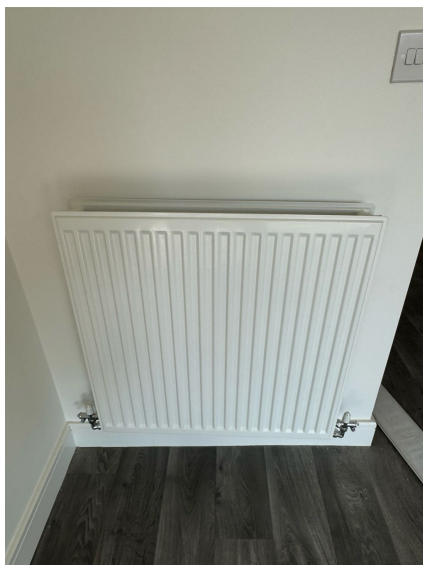
Defect number: 66

The lounge radiator is not level.

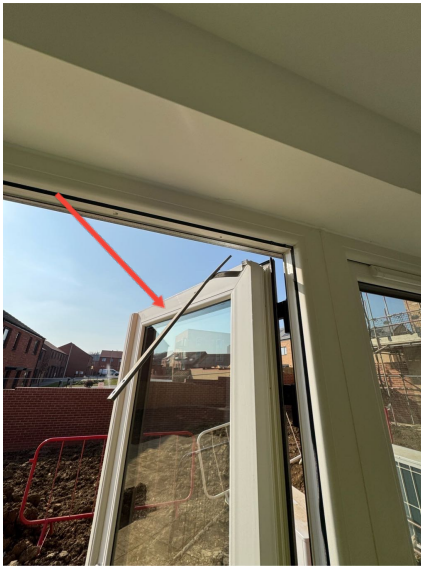
Defect number: 67

The patio door restrictor is severely damaged and requires replacing.

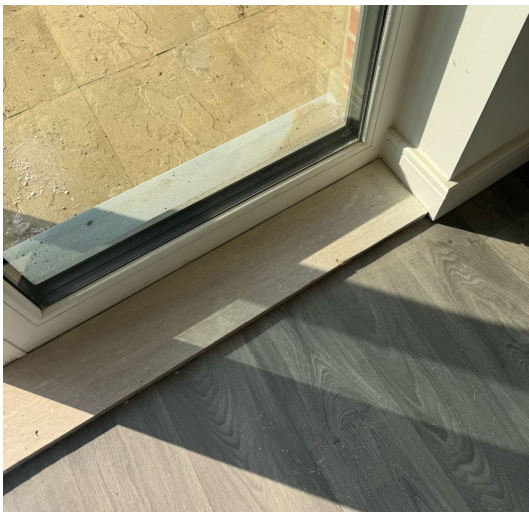
Defect number: 68

The patio door timber threshold requires decoration. It is currently in its natural colour and not in keeping with other thresholds on the development as per the developer's design.

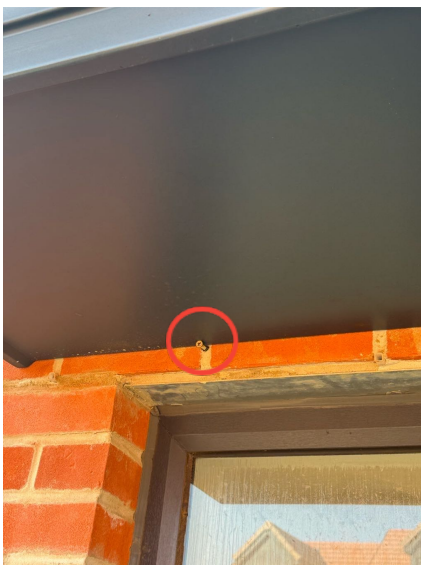
Defect number: 69

The porch canopy temporary fixing screws have been left in the brickwork above the front door opening and require removing. The bricklayer will need to use mortar to fill the holes once removed.

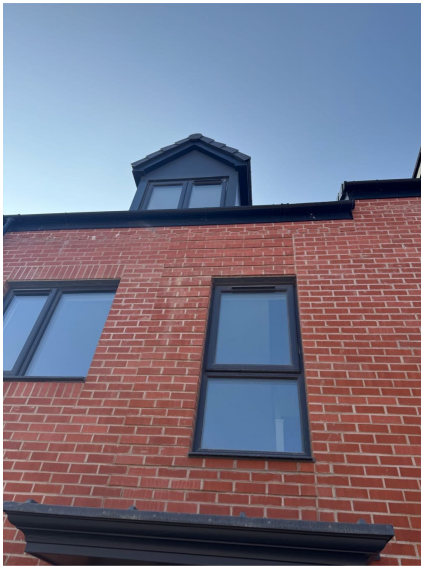
Defect number: 70

The brickwork has not been cleaned with an acid and pressure wash. All elevations require cleaning.

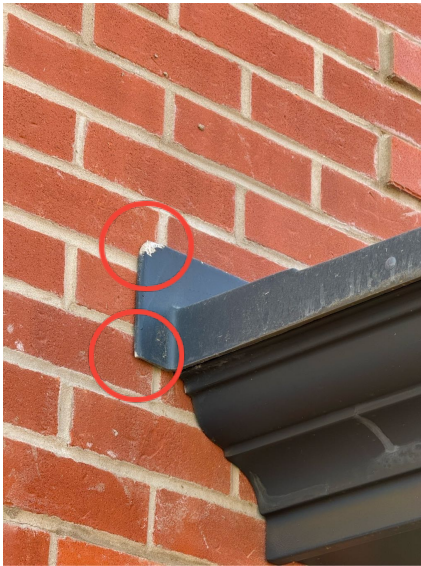
Defect number: 73

The porch canopy is damaged in various places and requires repairing. If sufficient repairs cannot be carried out then the canopy should be replaced.

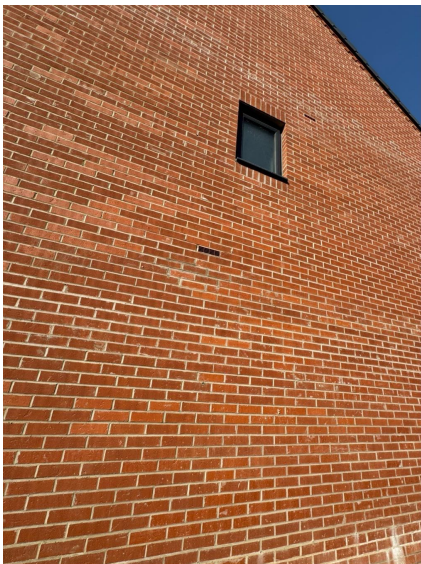
Defect number: 74

The brickwork needs cleaning. The same comment applies as per defect number 70.

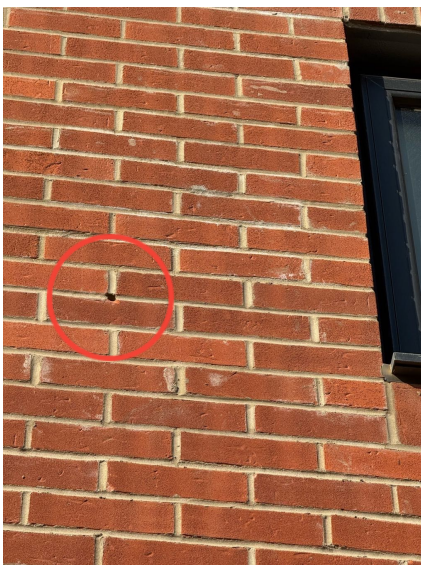
Defect number: 75

Mortar required to the small hole within the brickwork next to the bathroom window.

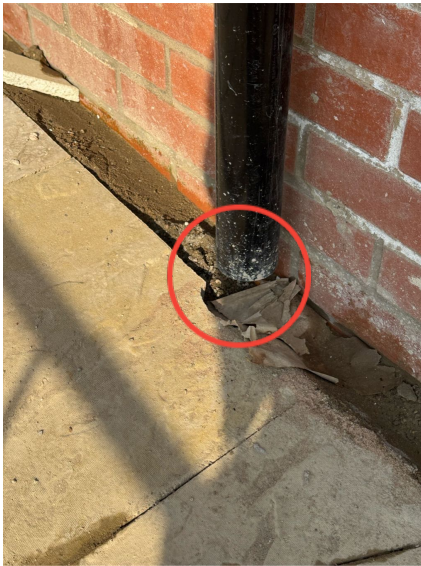
Defect number: 76

A drain has not been installed in order for the gutter's downpipe to be connected and to drain away rainwater from the house's roof.

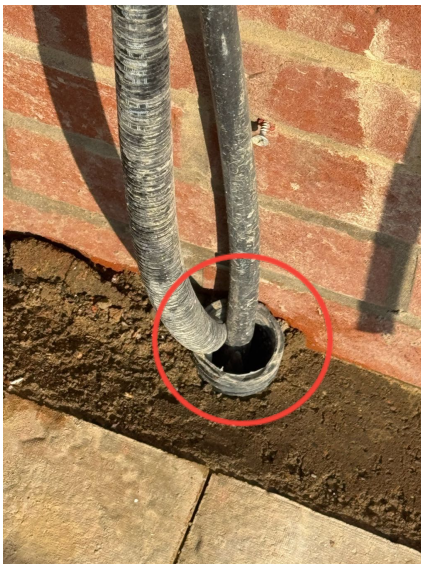
Defect number: 77

Tape or a cover should be put over the electrical service duct to prevent entry into the duct from the elements and flora and fauna.

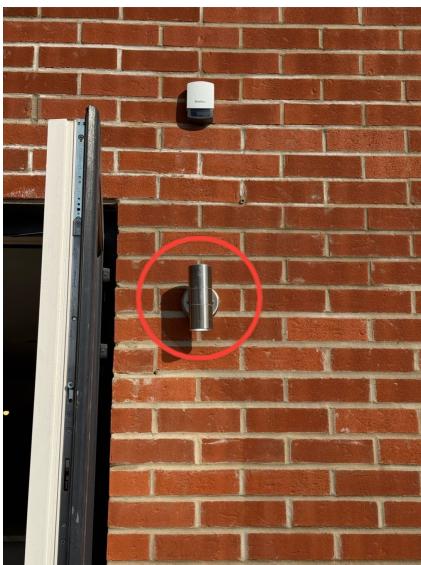
Defect number: 78

The light to the rear elevation is not level.
