EAGLE EYE®
NEW HOME INSPECTIONS

PRE-COMPLETION INSPECTION REPORT

1 Example Road, Example
Town, Hertfordshire,
SW1A 1AA

23rd April 2025

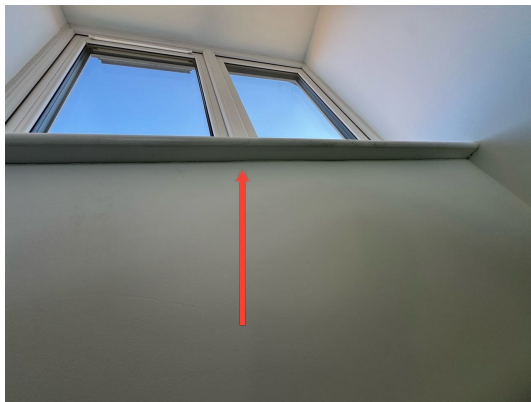
Defect number: 13

The dormer window board requires re-decorating.

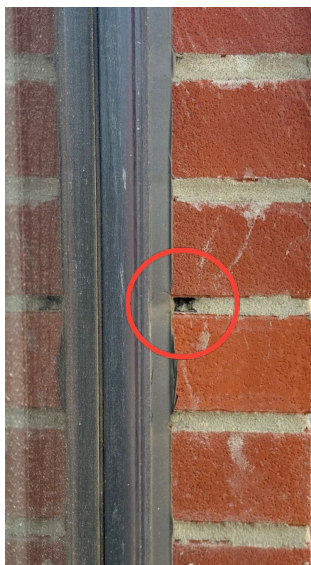
Defect number: 29

There are various marks to the landing window frame. These need to be repaired if they cannot be cleaned off.

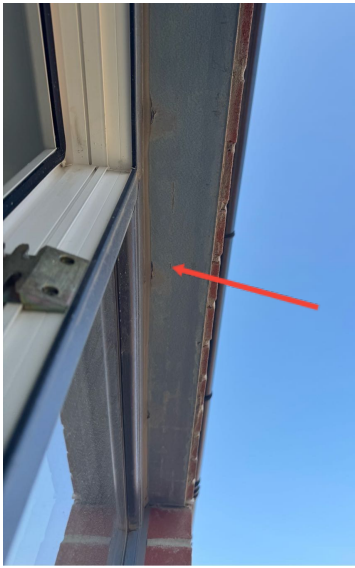
Defect number: 30

Mortar is required outside the landing window.

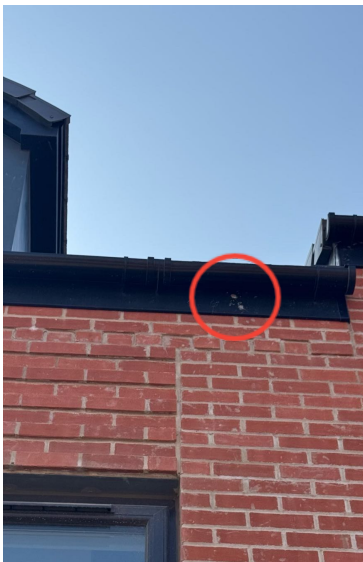
The brickwork has not been cleaned with an acid and pressure wash. All elevations require cleaning.
